STATE OF WASHINGTON
DEPARTMENT OF ECOLOGY

Re: No Further Action at the following Site:

- **Site Name:** Auto Site Automotive
- **Site Address:** 11803 Des Moines Memorial Drive South, Seattle, WA 98168
- **Facility/Site No.:** 53457146
- **VCP Project No.:** NW2113

Enclosure A – Site Description and Diagram of Site

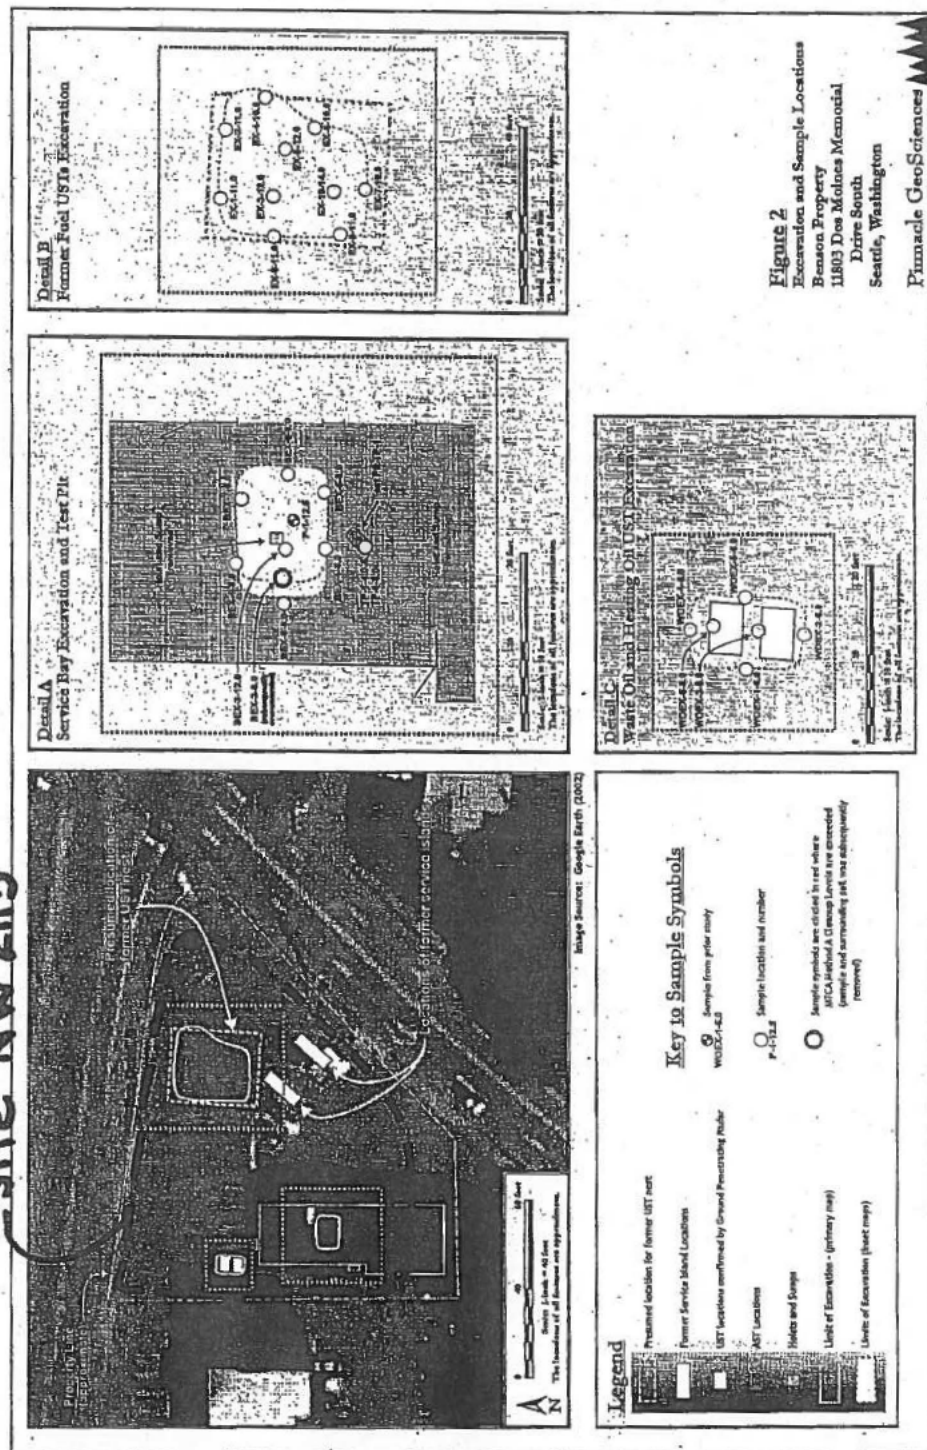
Figure 2
Excavation and Sample Locations
Benson Property
11803 Dos Molnos Memorial
Drive South
Seattle, Washington
Pinnacle GeoSciences

Approximate Boundary of Site NW 2113
